Report of Draught-Proofing Survey conducted at the Countess of Huntingdon's Chapel (Building of Bath Collection), Wednesday 5th February 2014.

Bill Martin, Jon McChesney and Jan Watterson (of Transition Bath Energy Group and the Centre for Sustainable Energy) attended and inspected the areas suggested by Jill Hunter, taking some thermal imaging photographs.

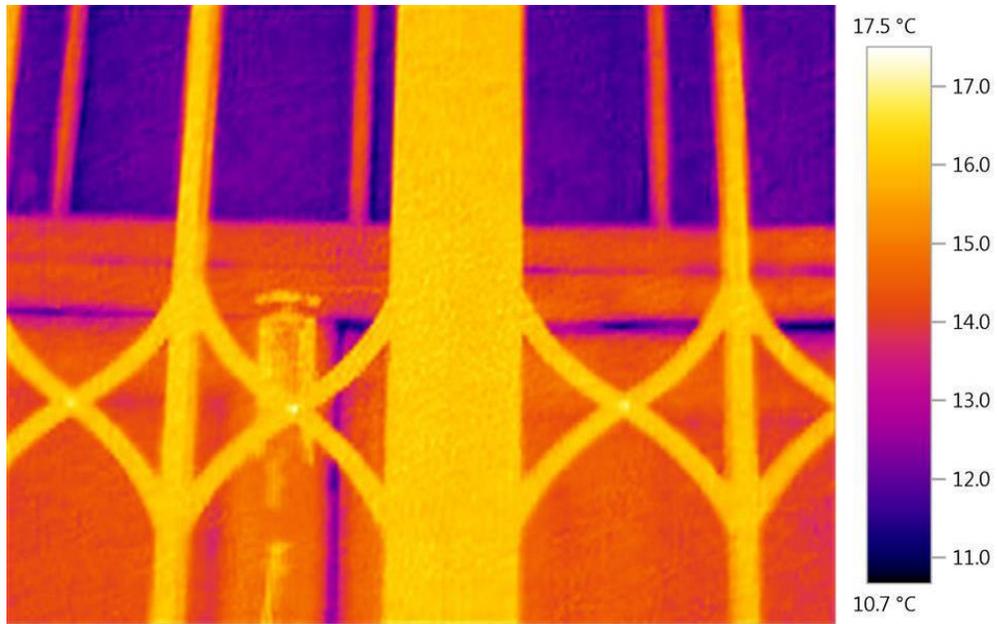
1.External door, Chapel south side.

Showing the heat loss from the windows above the door and the draught around the edges of the door.

We believe some significant improvements can be achieved with these external doors by the careful application of a combination of self-adhesive "P" & "E" section EPDM rubber draught excluder around the frames (see diagrams below). E section is for gaps 1.5-3mm and P section for 3-5mm. Fitting of brush strip draught excluder to the internal base of the doors should minimise draught from below.

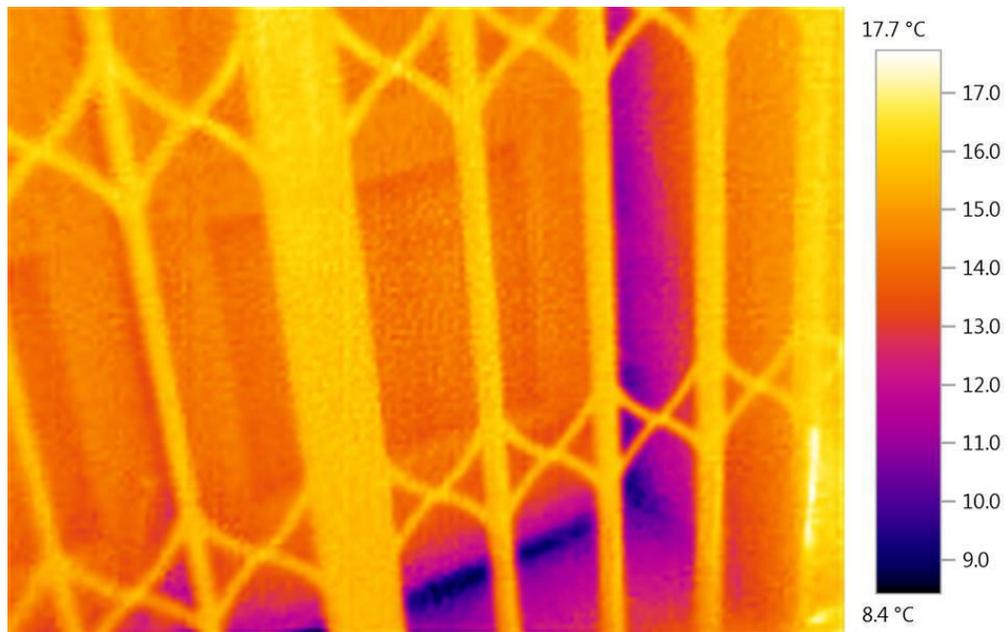
This (RHS at base of door) shows the ingress of cold air.

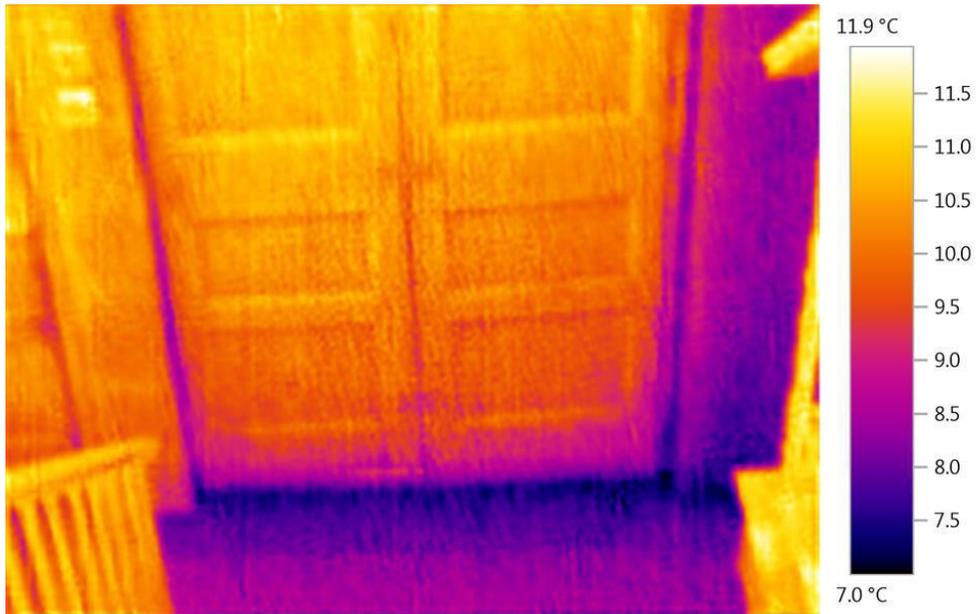
2. Double door in passage between chapel and reception.

Considerable ingress of cold air is seen at the base of the door and around the sides.

The self-adhesive materials are easily removable at a later date and are fitted discreetly – not visible when doors are closed and minimally so when the doors are open. Similar treatment at the closing stiles of double doors is also recommended.

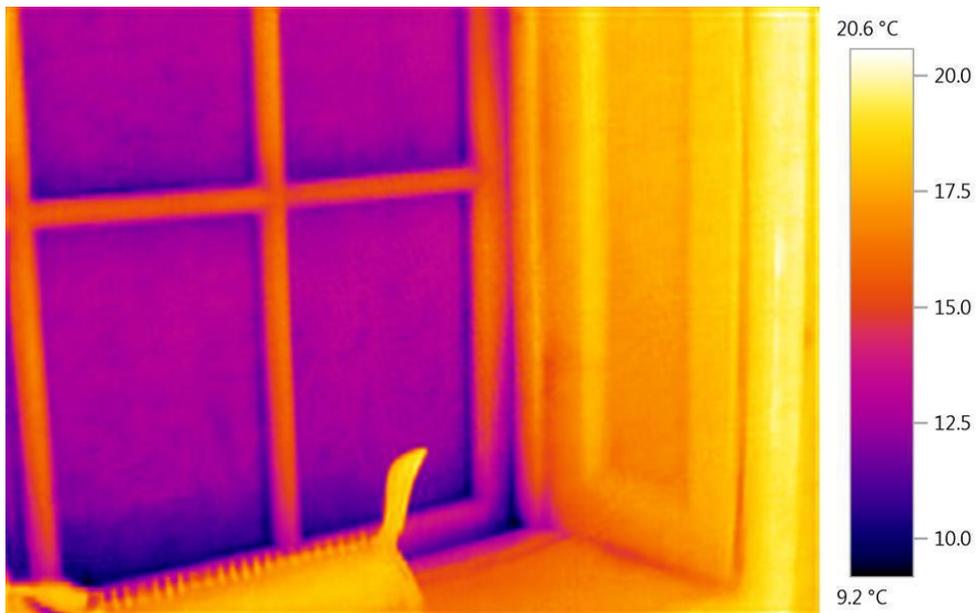
3. Sash window outside CMG Architect's office

The above sash window shows draught at base, right. Draught was also evident elsewhere around this window.

In addition, some draught proofing will be possible with the sash windows we observed in our survey. This would be done by fixing self-adhesive V strip (see below) in the gaps, as demonstrated at the museum recently. The opening deficiency we observed in one window would have to be remedied professionally.

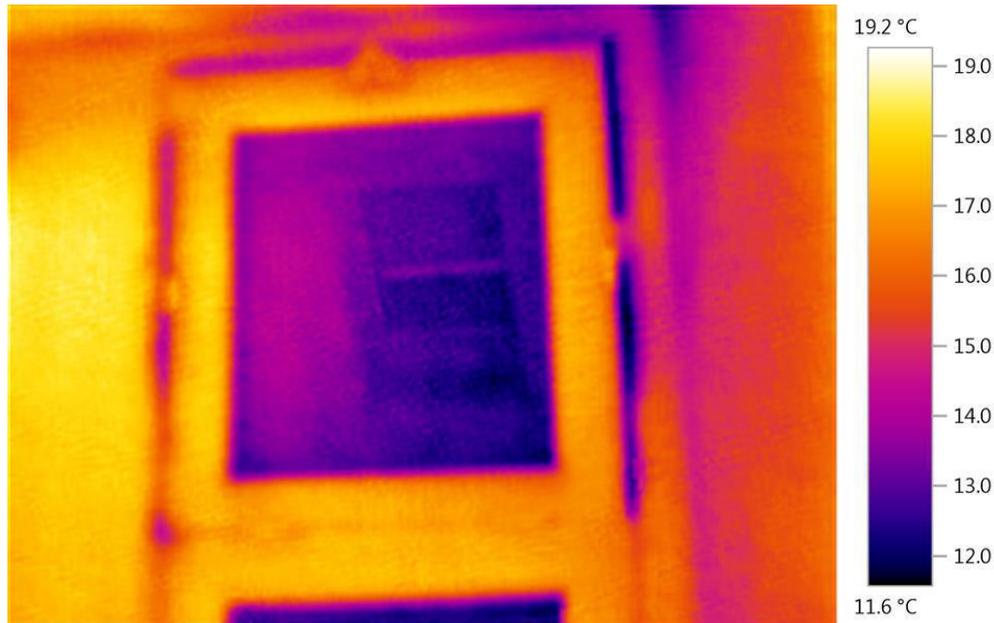
4. Schoolhouse window showing draught at right.
